# **ENVIRONMENTAL INFORMATION DOCUMENT**

**Ash Street Pump Station and Force Main**

**Northern KY Sanitation District No. 1**

**September 2013**

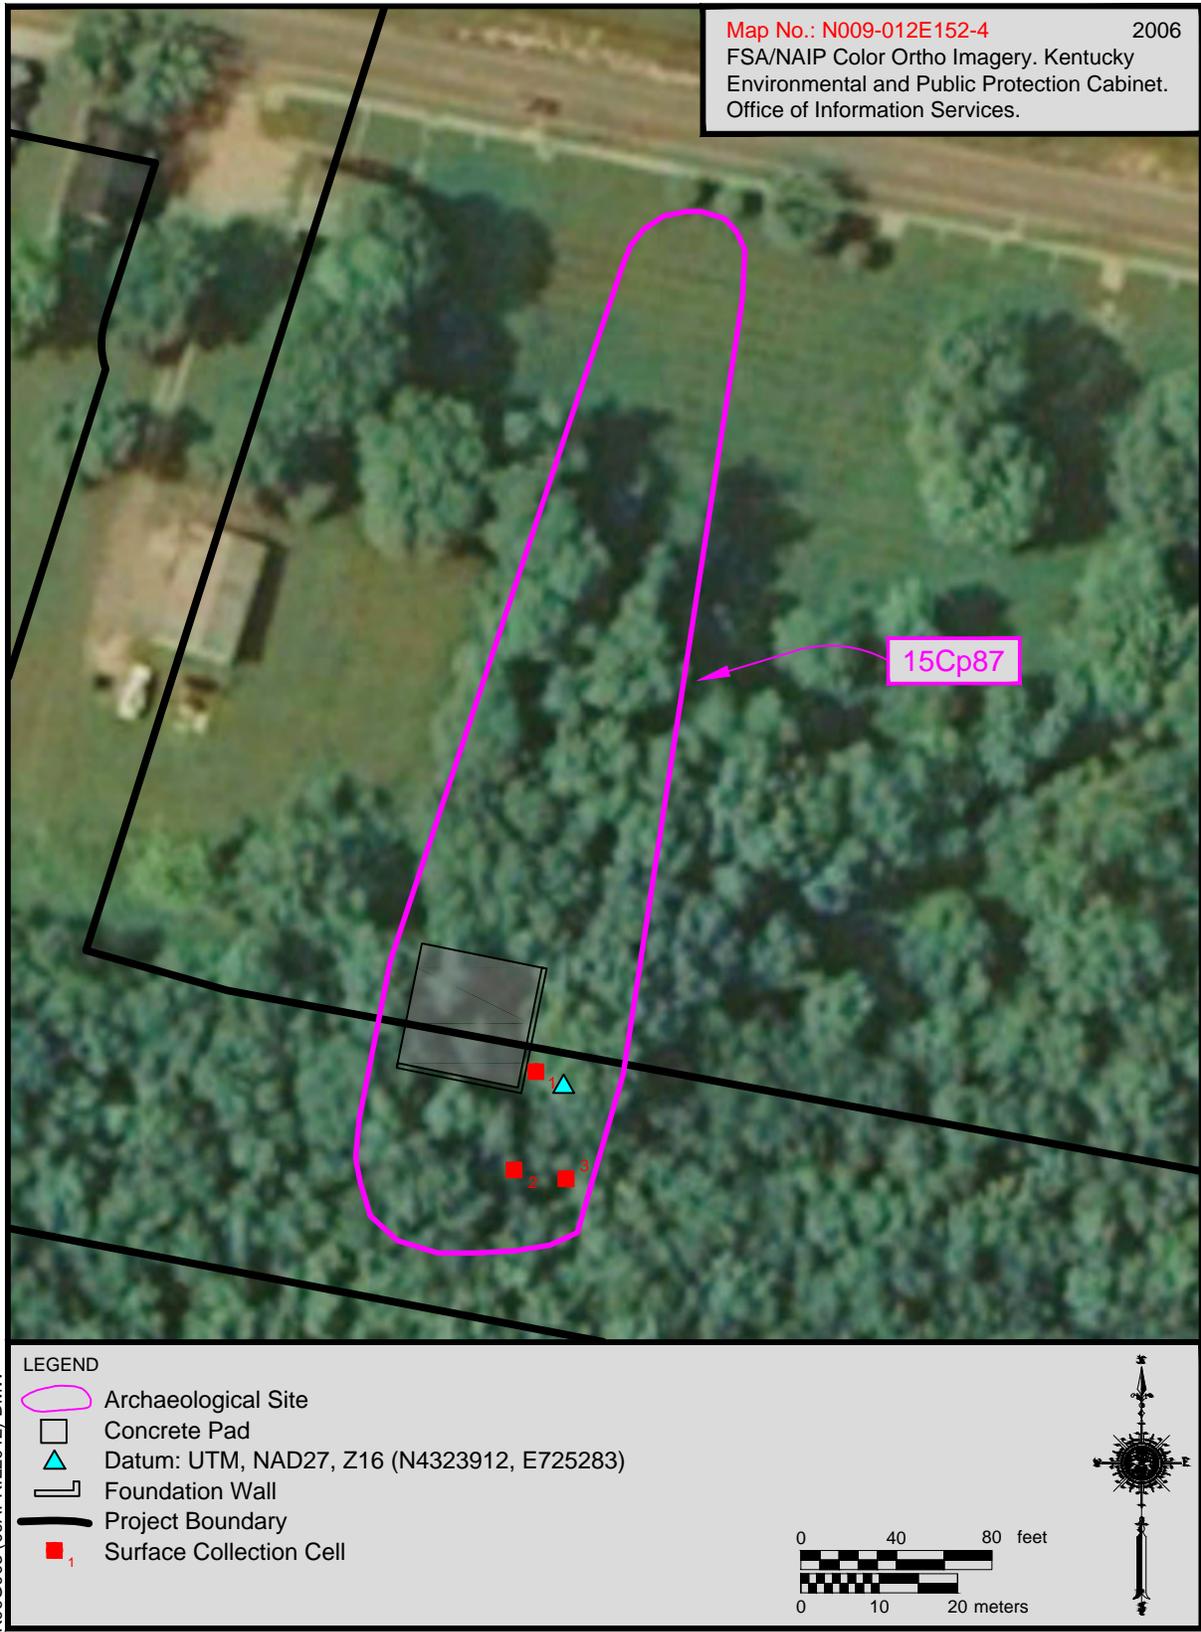
Figure 14. Schematic plan map of Site 15Cp87.

One archaeological site was documented during this survey. Site 15Cp87 is a historic residence dating from before 1900 through at least 1993. Within the current project area, the site consists of a concrete block outbuilding foundation and artifact scatter dating to before 1960. This outbuilding was probably associated with a house that stood on the same long residential lot from at least 1898 through at least 1993. The majority of the site, including the former house location, is outside of the current project area. Within the project area, the site has been heavily disturbed by demolition, the clearance of a right-of-way, and modern trash dumping. All artifacts were found on the surface around the partial foundation. No subsurface artifacts or features were found. The portion of Site 15Cp87 that lies within the project area has little depositional integrity and is recommended as not eligible for the National Register of Historic Places. Therefore, archaeological clearance for the proposed project is recommended. Should future project changes impact that portion of Site 15Cp87 outside of the current project area, further testing may be necessary.

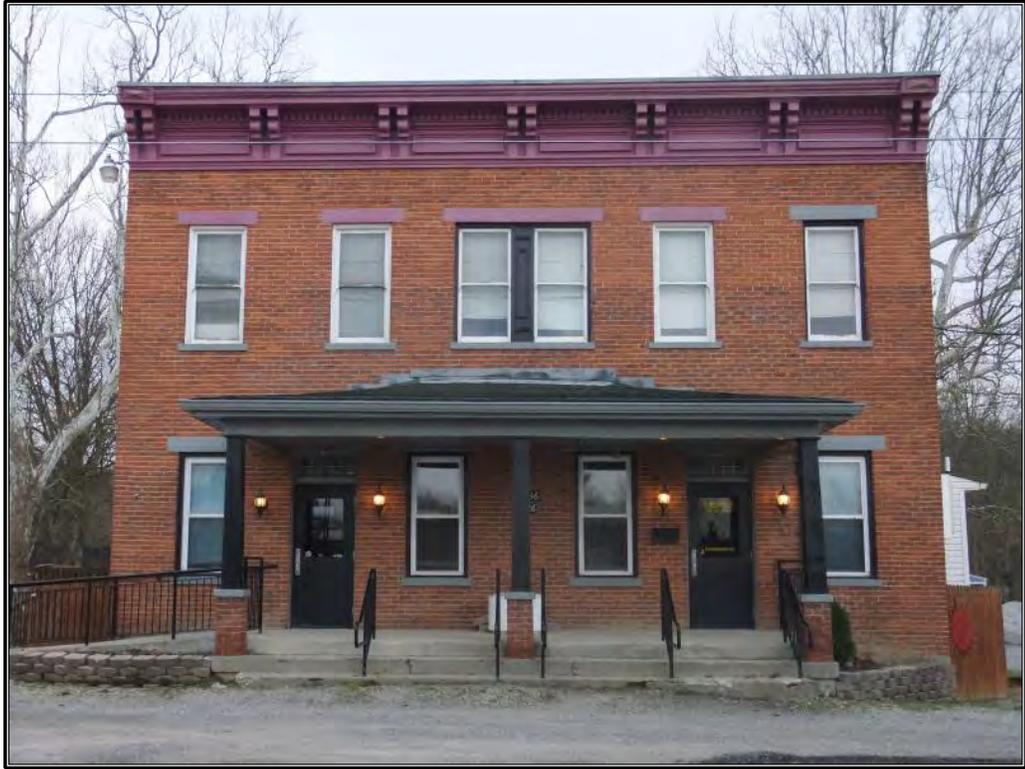
The two-story, six-bay (w/d/w/w/d/w), brick commercial building includes approximately 4,072 sq ft of floor space within its rectangular plan. It has a stretcher-bond brick exterior and rests on a continuous rusticated concrete-block foundation. The building’s roof, which discrepancies in the masonry of the southeast and northwest elevations indicate was raised at some point, features a parapet wall crowned with an Italianate-inspired bracketed cornice above the façade elevation (Figure 28). A single-story, hip-roofed porch with battered, boxed wood columns supported by brick piers shelters both single-leaf façade entries and the windows between them. Secondary single-leaf entries on the southeast elevation open onto a wood deck of recent construction. Projecting from the northwest elevation is a single-story, shed-roofed frame addition clad in vinyl siding (Figure 29). The building’s entry and window bays feature stone lintels and sills. The pedestrian entries on the façade and southeast elevations have half-light and multi-light replacement doors and glass-block transoms.

Figure 28. Site 16: façade elevation of commercial building.

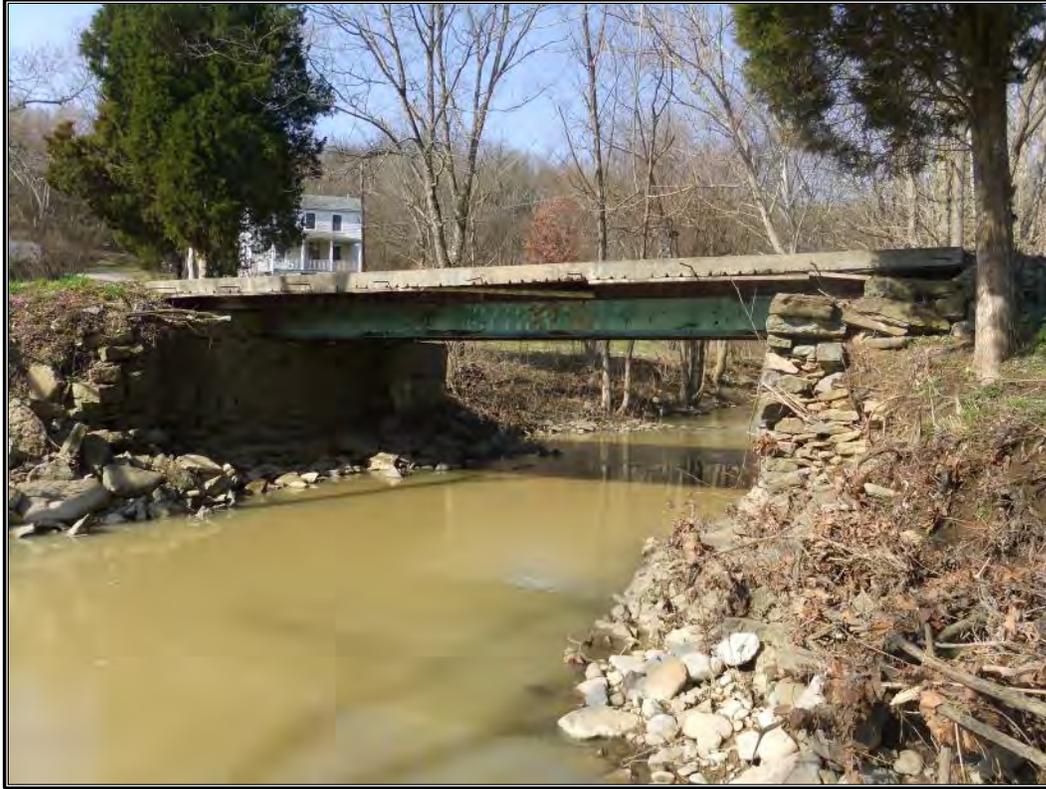
Figure 117. Site 96: reinforced-concrete slab and steel girder bridge.

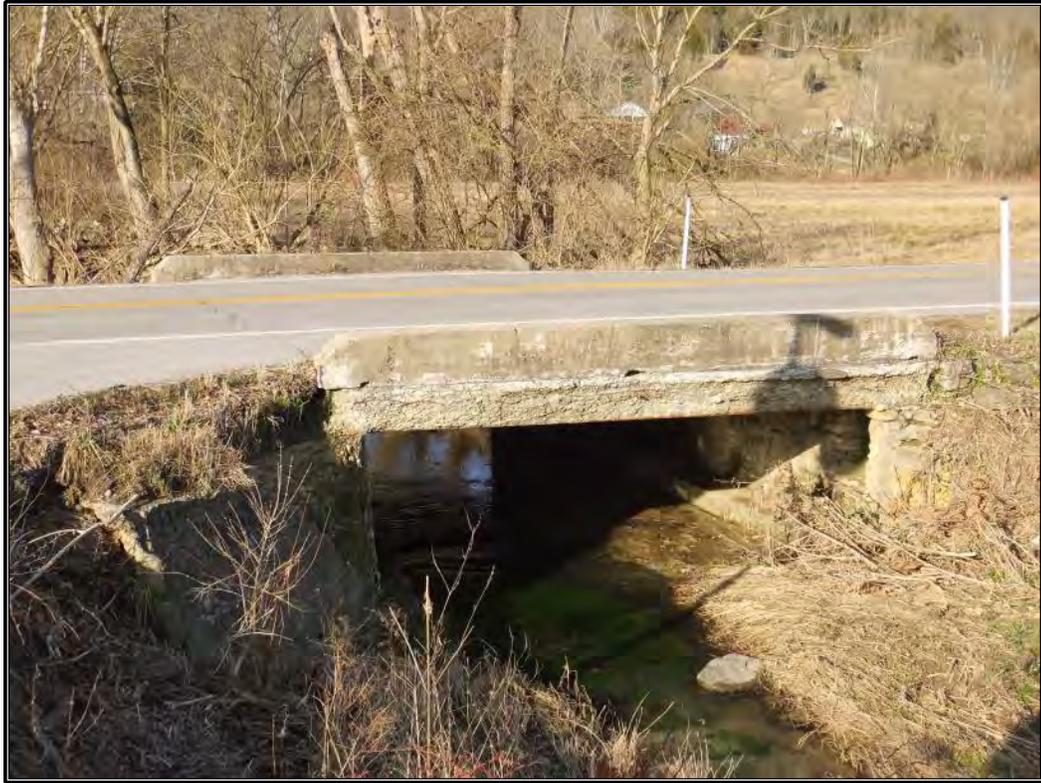
Figure 153. Site 111 (CP 312): reinforced-concrete slab bridge.

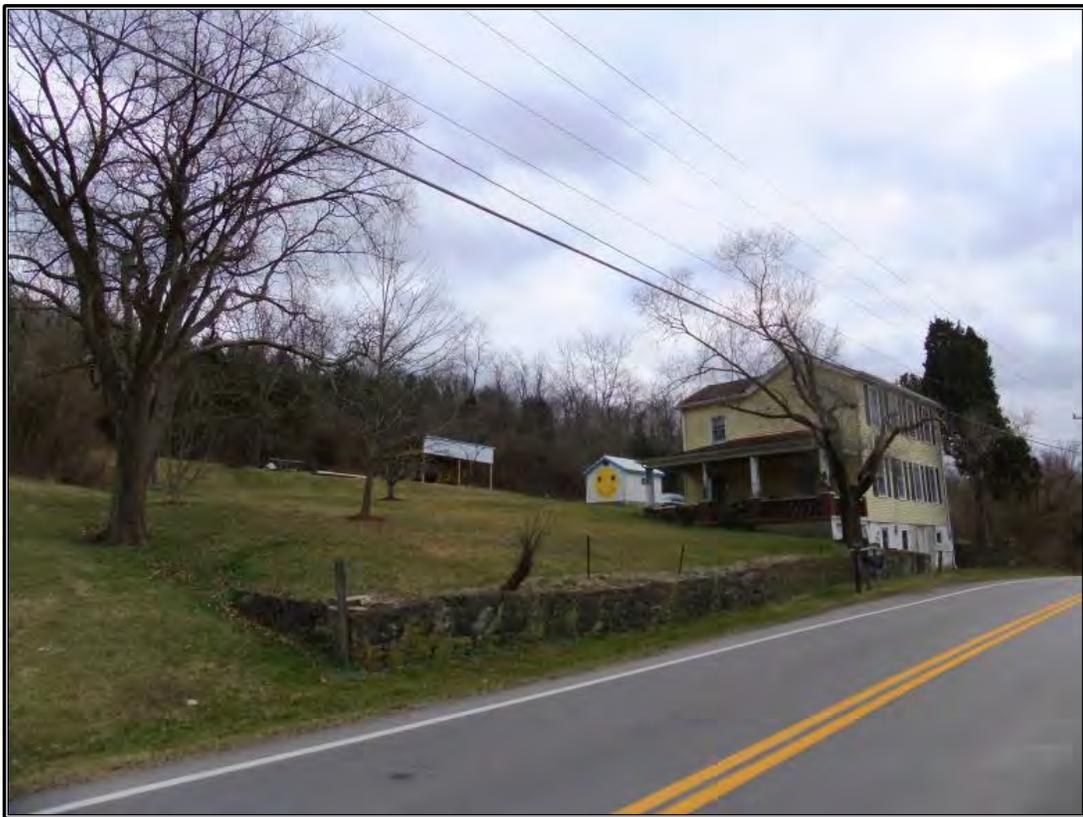
Figure 168. Site 115 (CP 316): mortared-stone retaining wall.
